Responding to a Mold Outbreak at the Catholic University of Toulouse

LAURA MONNEAU

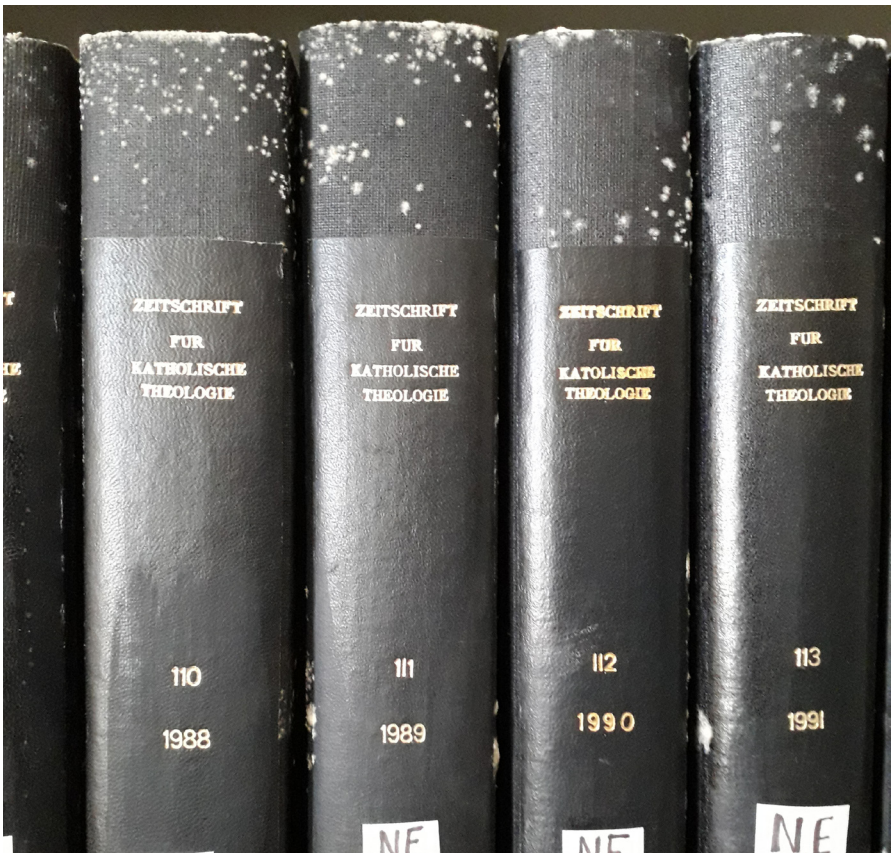
In 2013, we noticed mold on a few volumes of journals where 197 titles are shelved on 882 linear meters (see Image 5.1). The dates of these titles range from the end of the 19th century to the present day, and the types of binding vary: cloth, cardboard, paper, or coated paper. Thinking it was an isolated incident, we quarantined the few volumes that were affected, while monitoring the rest of the collection. Unfortunately, we soon observed that other volumes were also affected, so we started thinking about how to respond to what could now be regarded as a mold outbreak.

Image 5.1: One of the journals most affected

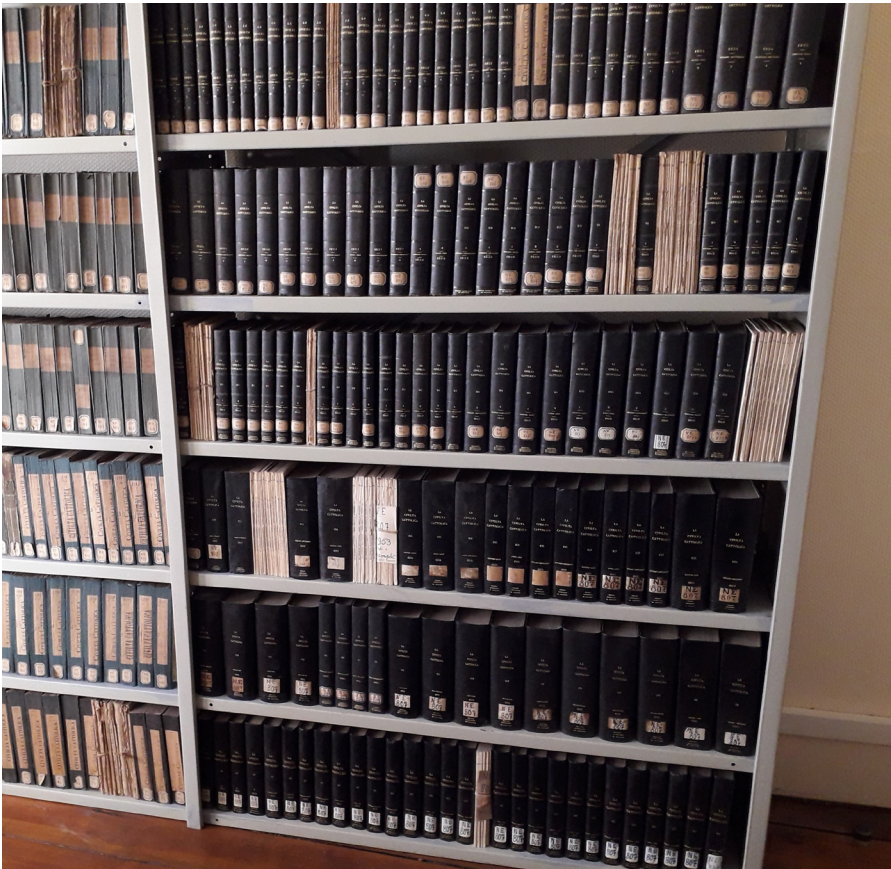
We first set up a quarantine space to isolate the volumes most affected. For this, we requisitioned new university rooms and had shelves and

sensors installed. These new sites had around 40 percent relative humidity, which was suitable for drying molds. The heavily affected volumes remained there for two months (see Image 5.2).

Image 5.2: One of the quarantine rooms

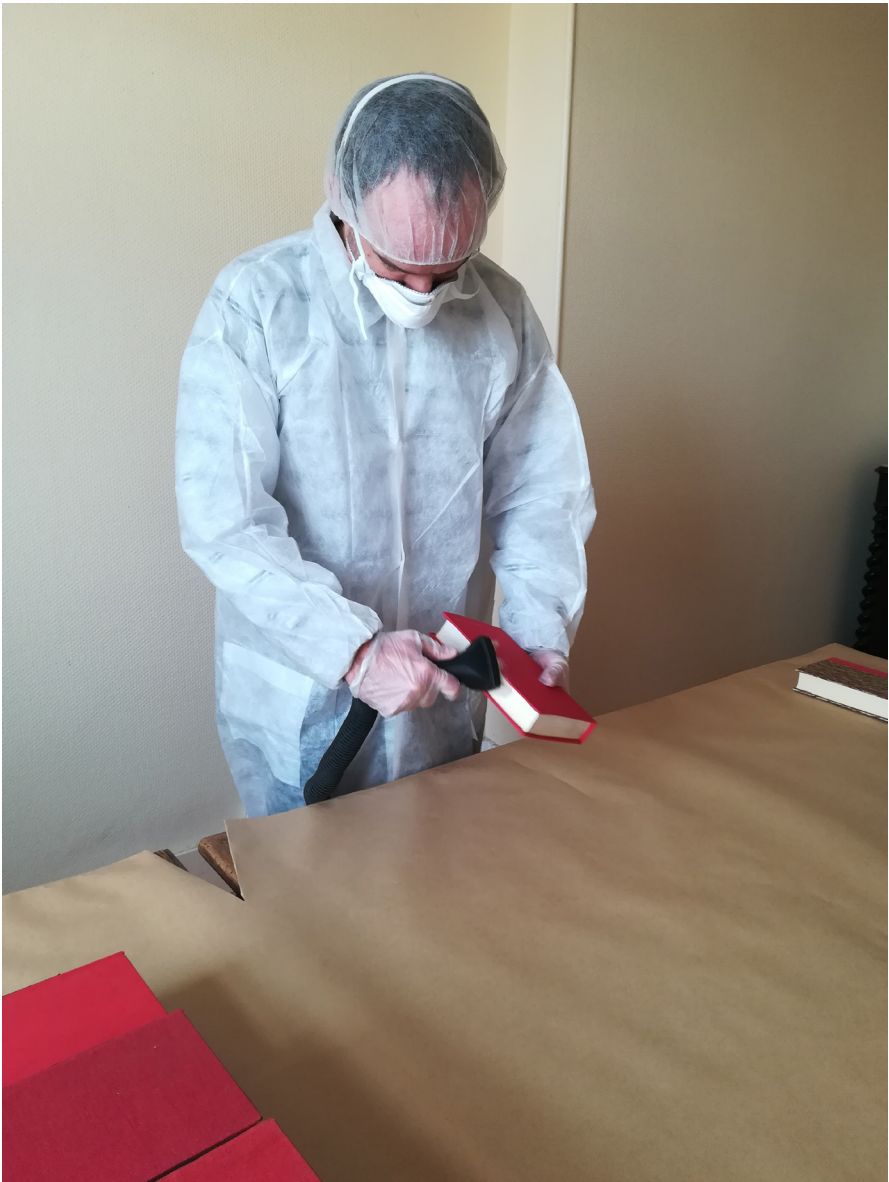
The dried materials were then transferred to a dust removal workstation and cleaned by our staff using equipment purchased for this purpose: a vacuum cleaner with an absolute filter (also known as a HEPA filter), brushes of different sizes and materials, and protective gear, such as gowns, gloves, and masks (see Image 5.3).

Image 5.3: Dust removal with staff protections

Staff varied the material of the brushes and the power of the vacuum cleaner according to the type of binding. For example, cloth bindings required longer and more powerful suction with a hard bristle brush than paper bindings. After treatment, we put the volumes back

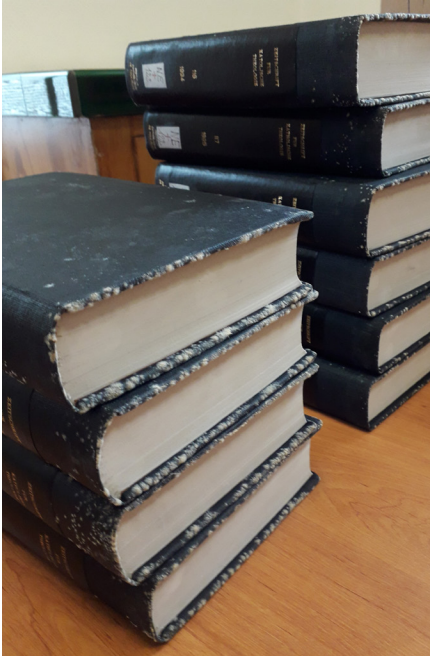
Image 5.4: Volumes before treatment

in quarantine in a second room, also with controlled humidity to ensure that the mold did not return. Two months later, we examined the volumes one last time. If they were fully dry, with no new mold, we moved them to a temporary clean stack space so that they would again be available to patrons, since sanitation of their original location had not yet been completed (see Image 5.4 and Image 5.5).
